The CTX-5000SP and Camera Films

Technical Report

International Imaging Industry Association (I3A)
(formerly known as National Association of Photographic Manufacturers, Inc. - NAPM)
701 Westchester Avenue, Suite 317W
White Plains, NY 10604
(914) 285-4933
Fax (914) 285-4937
E-mail: info@i3a.org
<http://www.i3a.org>

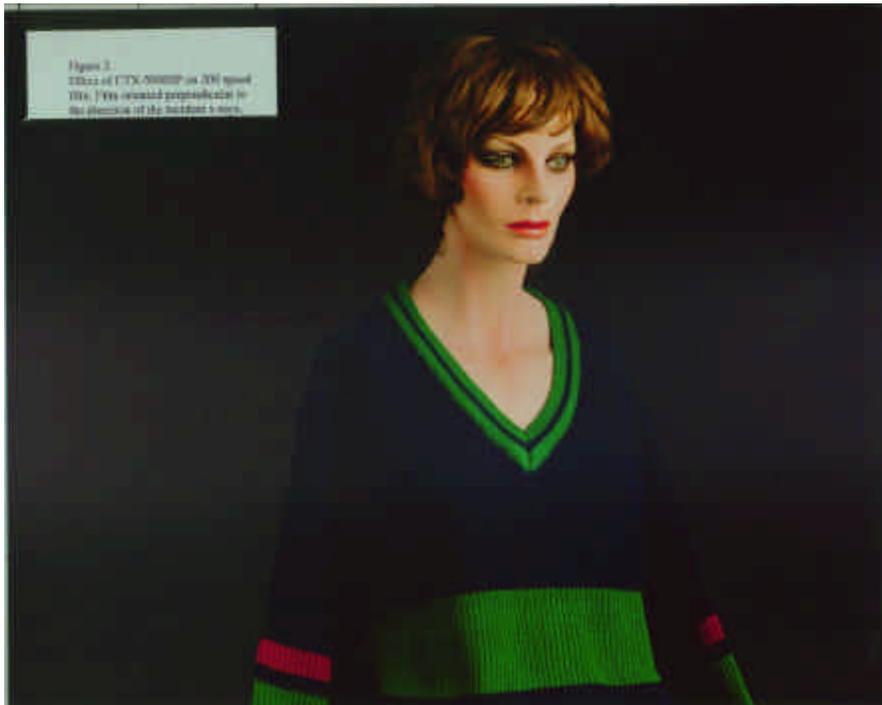
Experiment #3 again resulted in an approximately 1 cm-wide high-density line of the photographic emulsions. The orientation and shape of this line depends upon the orientation of the film relative to the incident X-rays. Figure 1¹ shows the scene selected. Figures 2 through 4 show the selected scene after exposure to the highly energetic X-ray beam in the CTX-5000SP for ISO 200, 400, and 800 speed films respectively. In these prints, the film was oriented perpendicular to the direction of the incident X-rays. Figure 5 shows the same scene on 400 speed film oriented parallel to the incident X-rays, while Figure 6 shows the film oriented at 45 degrees relative to the incident X-rays.

**Figure 2 – Effect of CTX-5000SP on ISO 200 speed film.
Film oriented perpendicular to the direction of the incident X-rays**

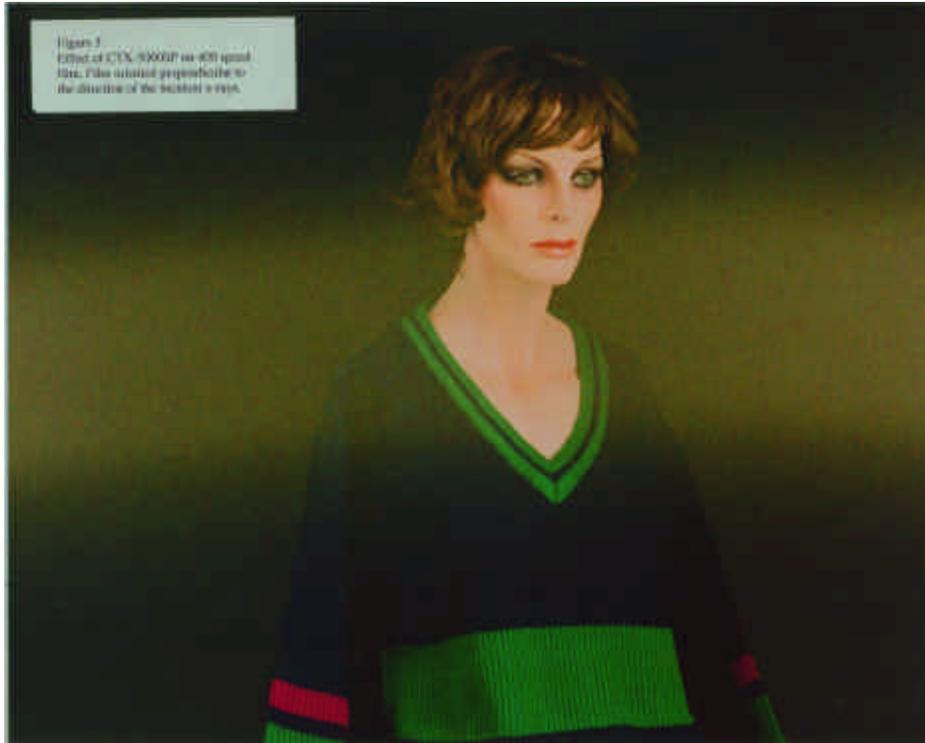
**Figure 3 – Effect of CTX-500SP on ISO 400 speed film.
Film oriented perpendicular to the direction of the incident X-rays**

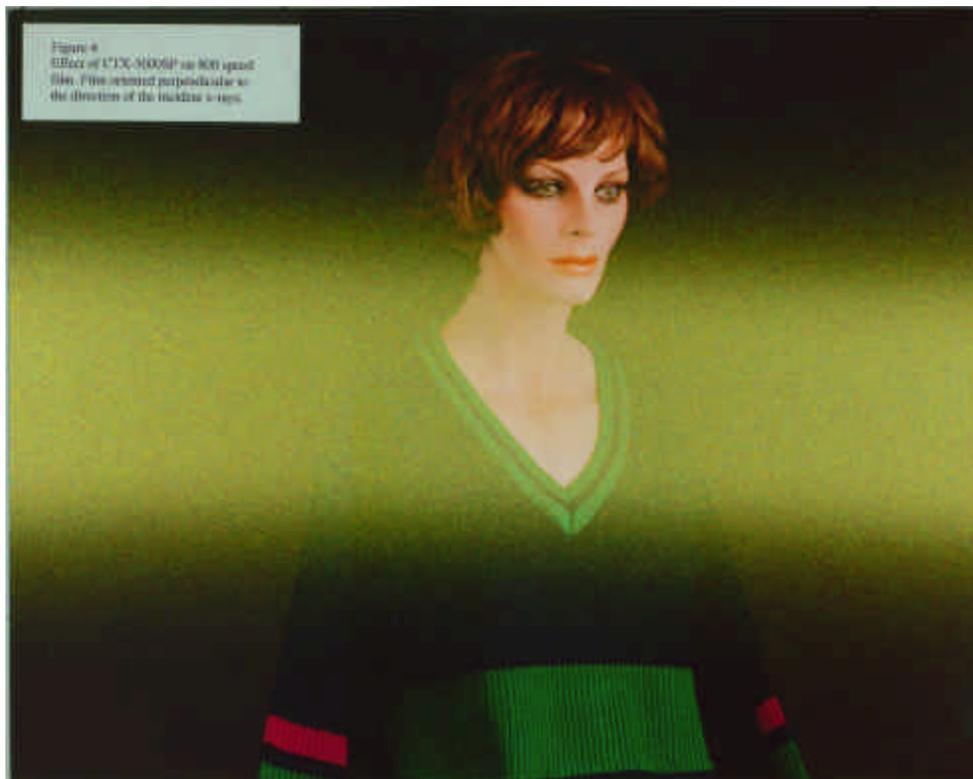
**Figure 4 – Effect of CTX-500SP on ISO 800 speed film.
Film oriented perpendicular to the direction of the incident X-rays**

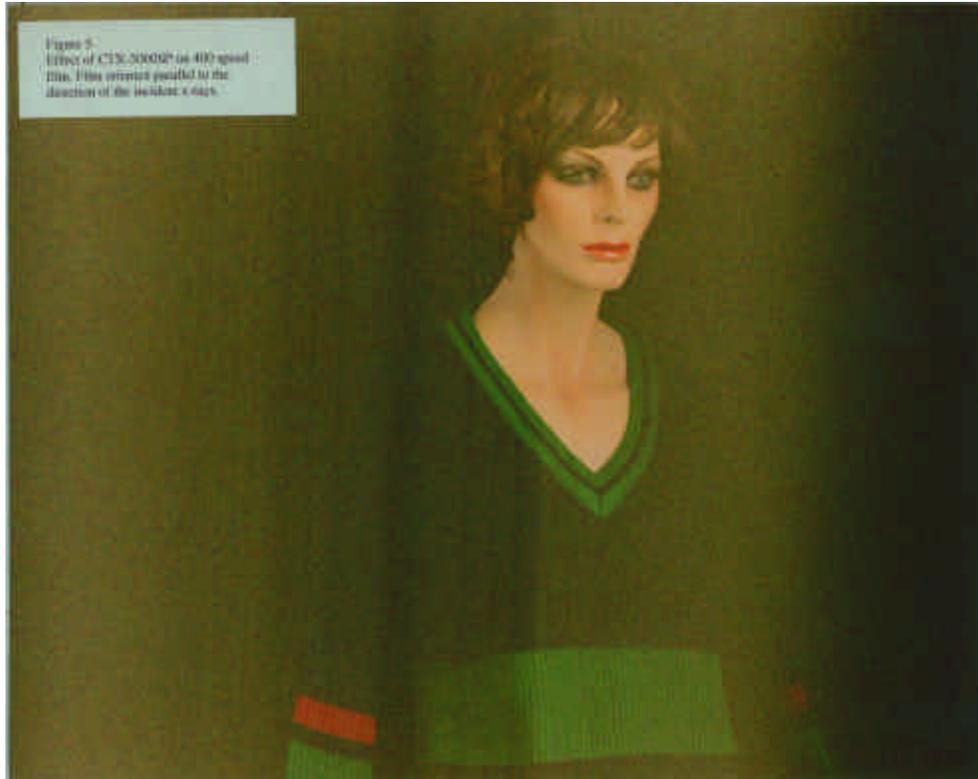
**Figure 5 – Effect of CTX-500SP on ISO 400 speed film.
Film oriented parallel to the direction of the incident X-rays**

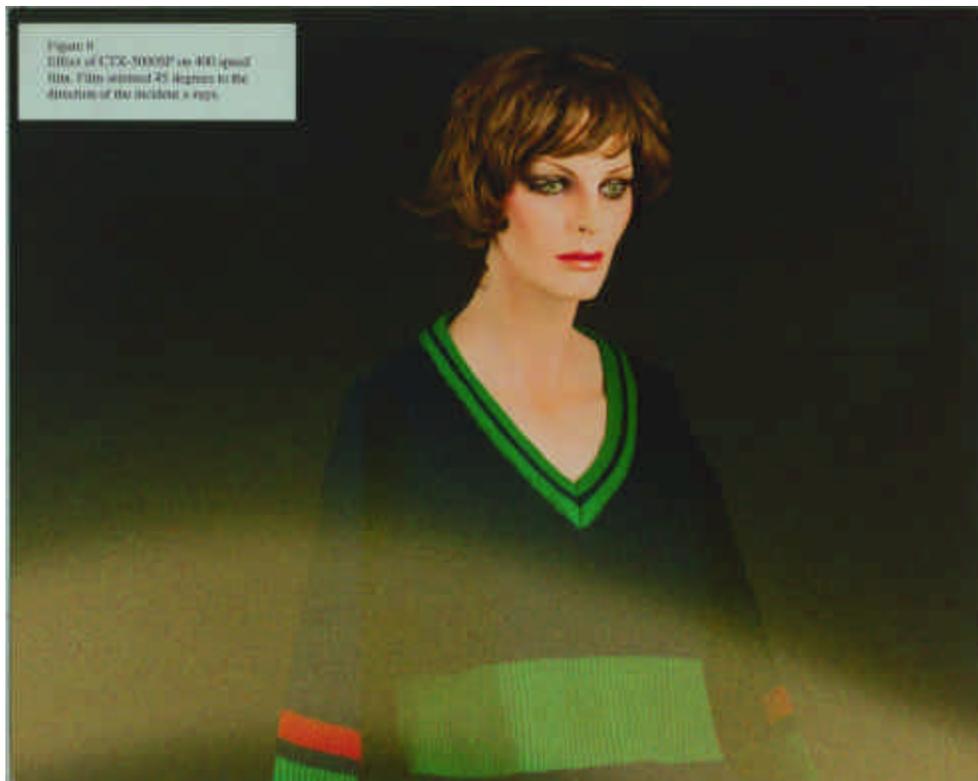
**Figure 6 – Effect of CTX-500SP on ISO 400 speed film.
Film oriented 45° to the direction of the incident X-rays**

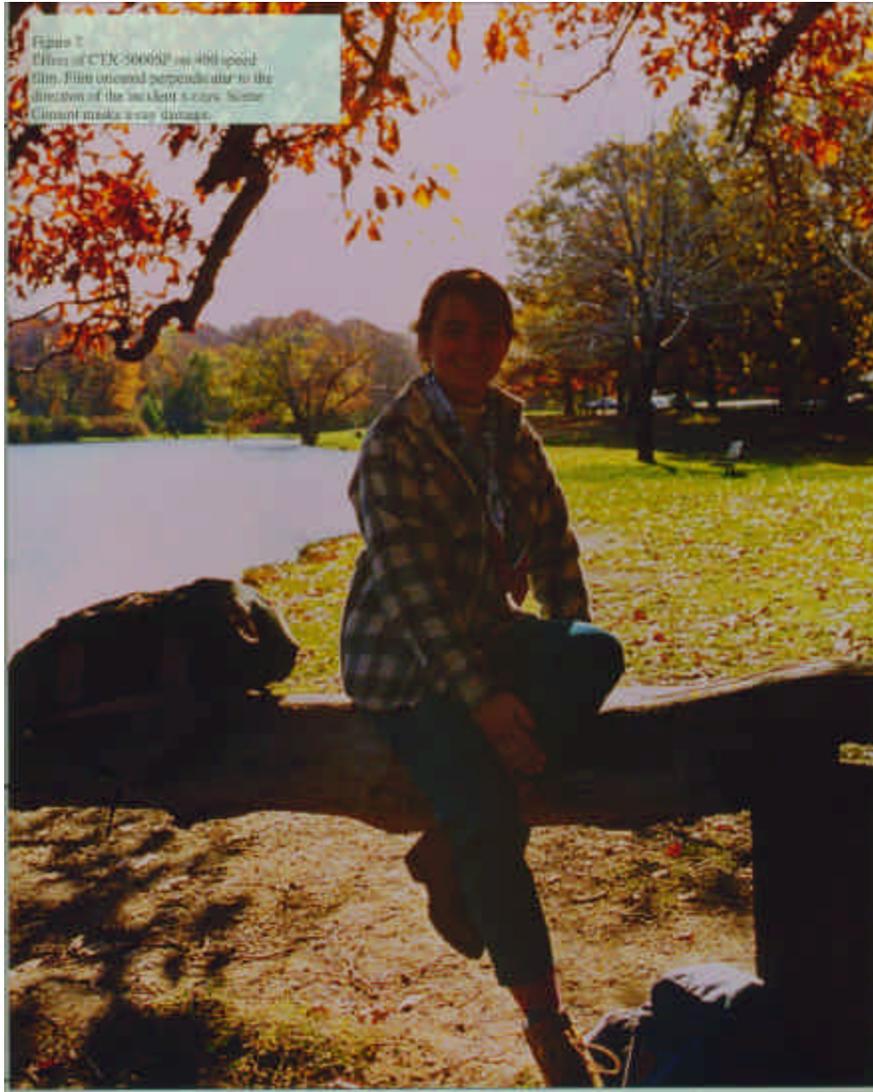
Additionally, Figures 7 and 8 show scenes from negatives exposed to the high energy X-rays that, due to scene content, do not show the X-ray damage.

**Figure 7 – Effect of CTX-500SP on ISO 400 speed film.
Film oriented perpendicular to the direction of the incident X-rays.
Scene content masks X-ray damage**

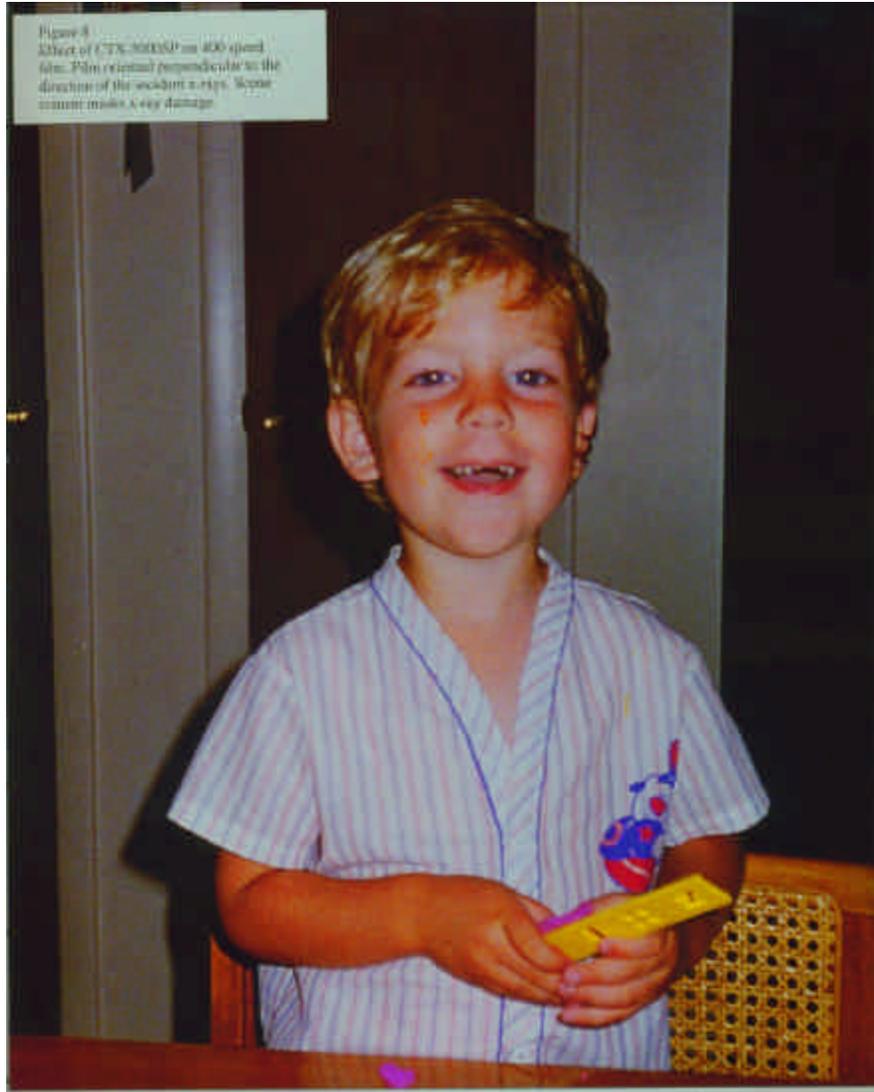
**Figure 8 – Effect of CTX-500SP on ISO 400 speed film.
Film oriented perpendicular to the direction of the incident X-rays.
Scene content masks X-ray damage**
