The CTX-5000SP and Camera Films

Technical Report

International Imaging Industry Association (I3A)
(formerly known as National Association of Photographic Manufacturers, Inc. - NAPM)
701 Westchester Avenue, Suite 317W
White Plains, NY 10604
(914) 285-4933
Fax (914) 285-4937
E-mail: info@i3a.org
<http://www.i3a.org>

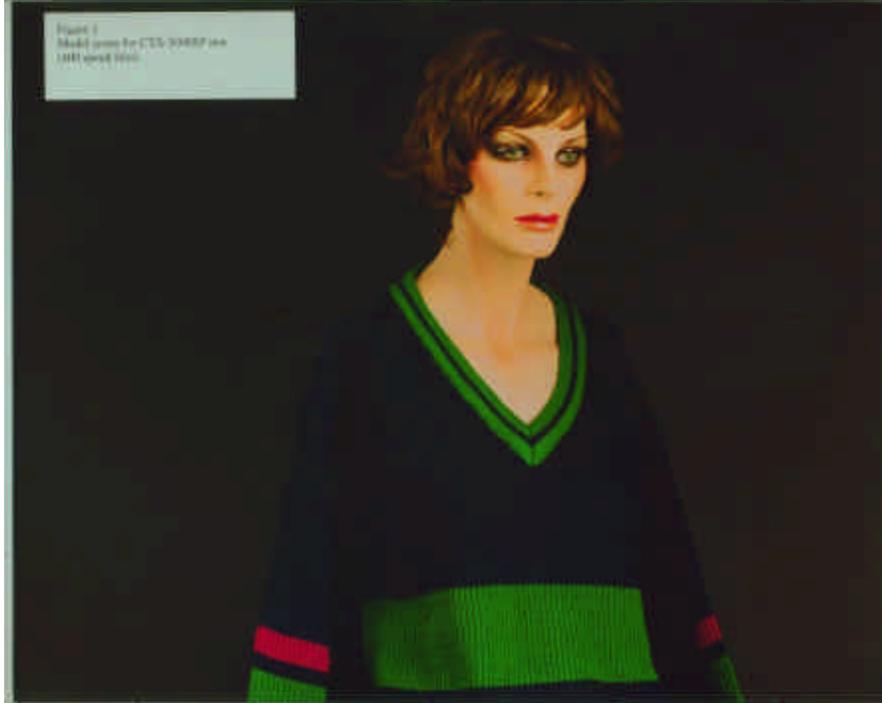
Experiment #3 again resulted in an approximately 1 cm-wide high-density line of the photographic emulsions. The orientation and shape of this line depends upon the orientation of the film relative to the incident X-rays. Figure 1¹ shows the scene selected. Figures 2 through 4 show the selected scene after exposure to the highly energetic X-ray beam in the CTX-5000SP for ISO 200, 400, and 800 speed films respectively. In these prints, the film was oriented perpendicular to the direction of the incident X-rays. Figure 5 shows the same scene on 400 speed film oriented parallel to the incident X-rays, while Figure 6 shows the film oriented at 45 degrees relative to the incident X-rays.

**Figure 1 Model scene for CTX-5000SP test
ISO 400 Speed film**
